# State Route 97 – Pateros to the Canadian Border

## SCENIC BYWAY APPLICATION VISUAL ANALYSIS DISCIPLINE REPORT

July 2002

**Washington State  
Department of Transportation**

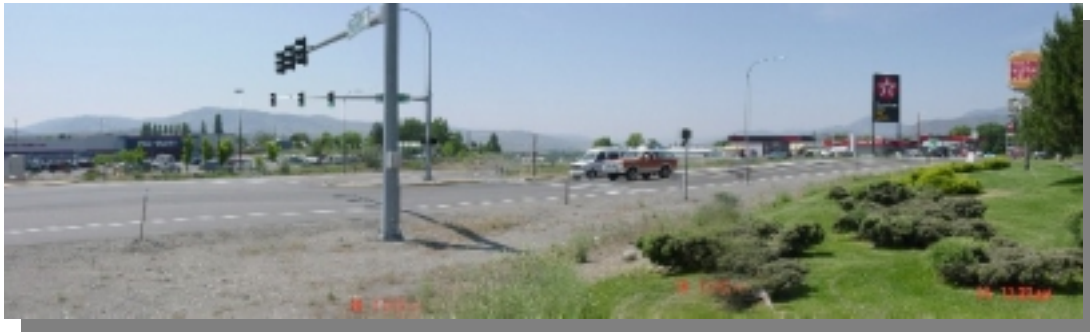
**Figure 1. SR 97 and SR 215 Intersection, MP 293.17**

For cumulative ratings, cut-off scores for “non scenic” or “scenic” thresholds were determined by comparing scores for two separate locations side by side – one considered “not scenic” and one “scenic.” This method was repeated five times to determine the scenic threshold. Figure 1 shows the intersection of SR 97 and SR 215 in Omak. This strip-mall type development is not considered “scenic.”

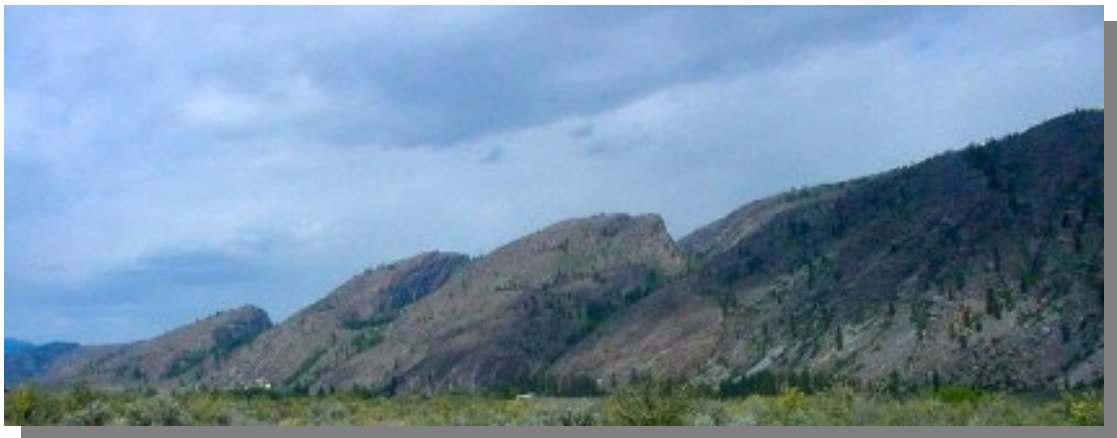
**Figure 2. Mountain formations northeast of Riverside, MP**

In contrast, Figure 2 shows a “highly scenic” view approximately three miles north of the photo above.

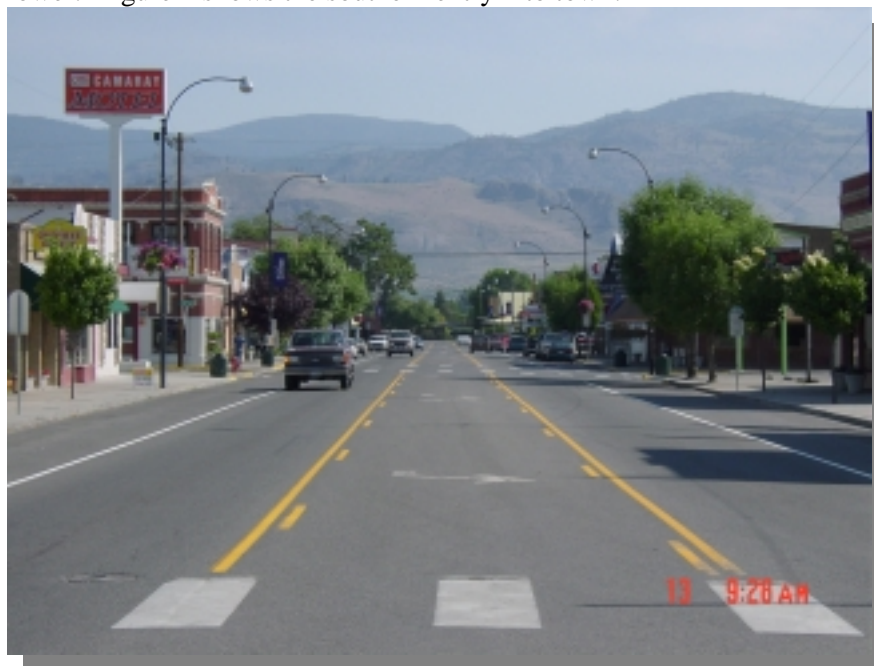
**Figure 4. Downtown Oroville northbound. MP 332.0**

Within the town of Oroville, the same comparison was made to determine thresholds by comparing two semiurban views. MP 331.93 is at the southern entry to Oroville. This section of the city has flower baskets hanging from light posts, banners, and street trees, which make it a very attractive downtown. Comparatively, a shopping center with large, a unlandscaped parking lot marks the northern entry into the city. Its visual quality ratings are much lower. Figure 4 shows the southern entry into town.

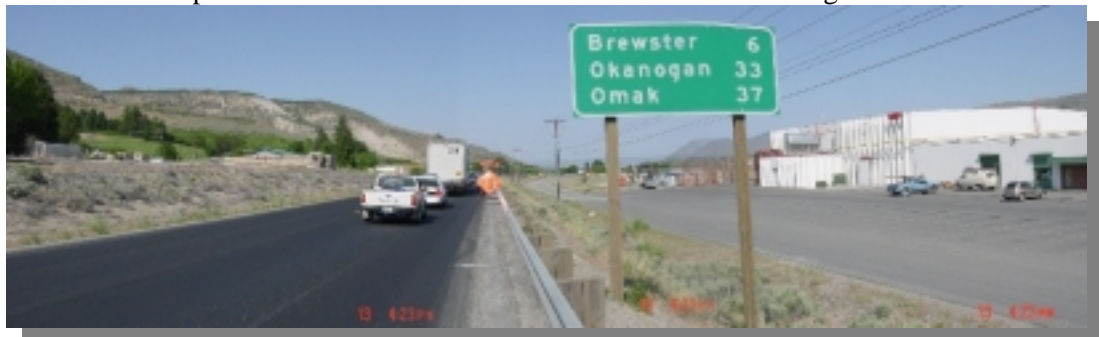
**Figure 6. Industrial area in Pateros, northbound Landscape Unit 1**

Within Landscape Unit 1 are industrial locations such as the one in Figure 6.

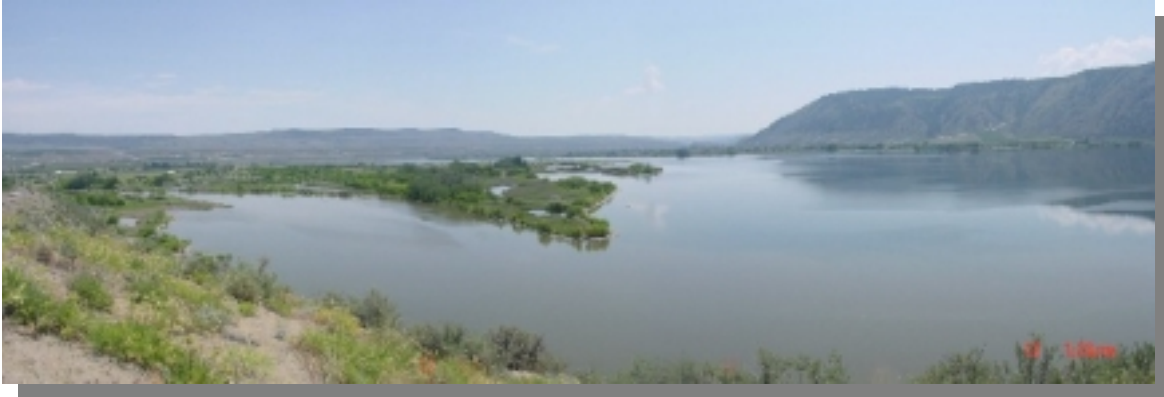
**Figure 11. Topography in Landscape Unit 1**

State Route 97 runs east-west between MP 253 and MP 265. The topography is characterized by the Columbia River to the south of the highway and mountains and hills rising to the north. Figure 4 shows the topography seen from the overlook near MP 263. This photo shows the confluence of the Okanogan River as it flows into the Columbia River. This is also the physiographic boundary between the Columbia Plateau, seen at the right, and the Okanogan Highlands that rise, out of view in this photo, to the left.

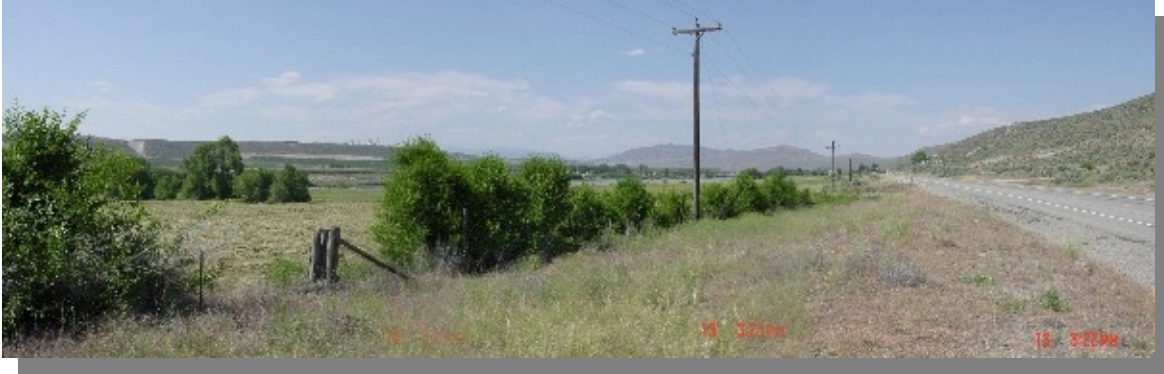
**Figure 16. Typical landforms in Landscape Unit 2**

Landscape Unit 2 is defined by hills rising to the east of the road and the Okanogan River to the west. In this Landscape Unit, there are occasional views of the river. Landscape Unit 2 runs from MP 265.1 to MP 272.5. Typical topography is shown in Figure 5 at MP 266.68.

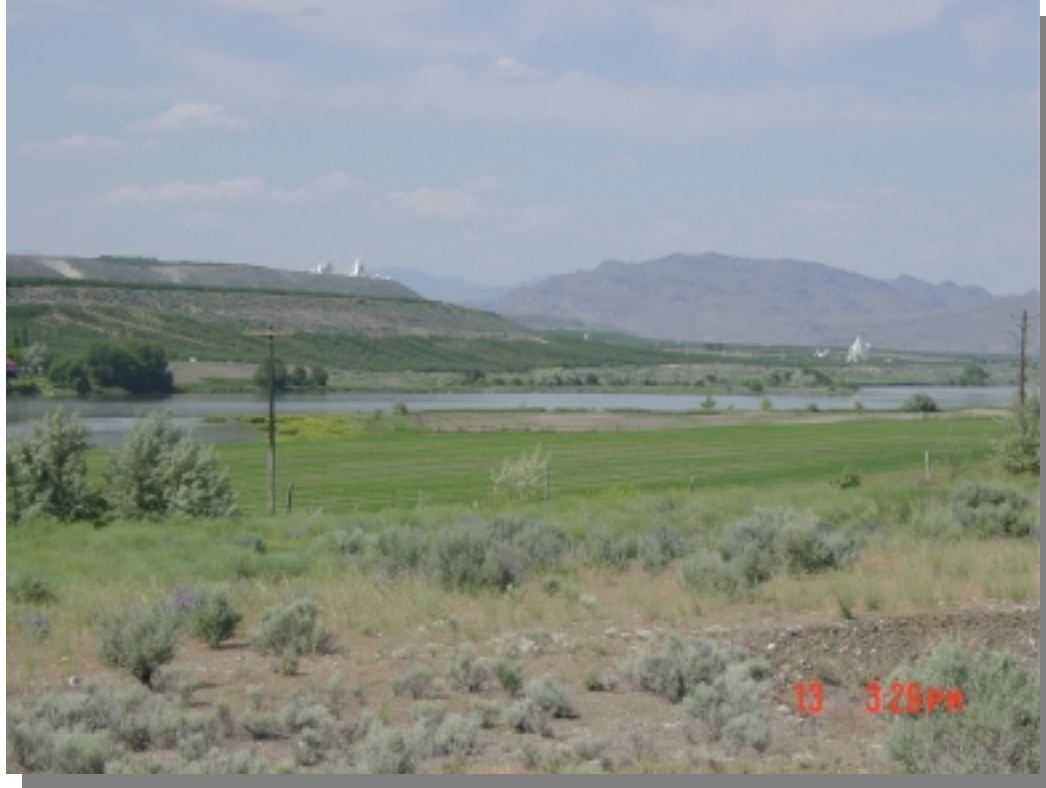
**Figure 21. Satellite dishes seen from MP 266.68**

A notable cultural phenomenon in Landscape Unit 2 is the presence of the satellite dishes that are used for communication, currently run by Veristar. Visually, they stand out in this rural landscape, yet they do not encroach.

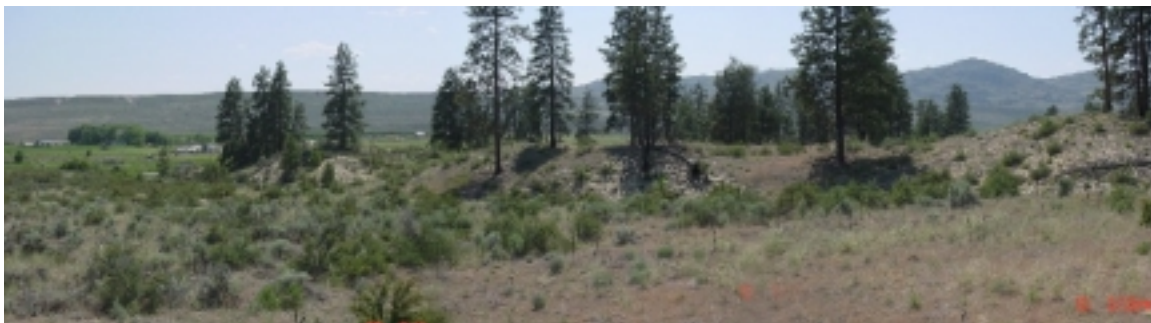
**Figure 22. Ponderosa pine forest and sand dunes in Landscape Unit 3.**

Landscape Unit 3, which runs from MP 272.5 to MP 274.3, bisects an area of ancient sand dunes and old-growth Ponderosa pines. This landscape unit has a forested character. These trees have colonized this sandy soil and have existed here before white settlers came. In much of the study area there is a feeling of prospect, or the ability to look out over long distances. In this Landscape Unit, there is a feeling of refuge and enclosure that is distinctly different from other sections of the corridor.

Northward, within this Landscape unit, the pines grow thicker. Figure 22 shows the northern end of Landscape Unit 3 with the characteristic Ponderosa pines.

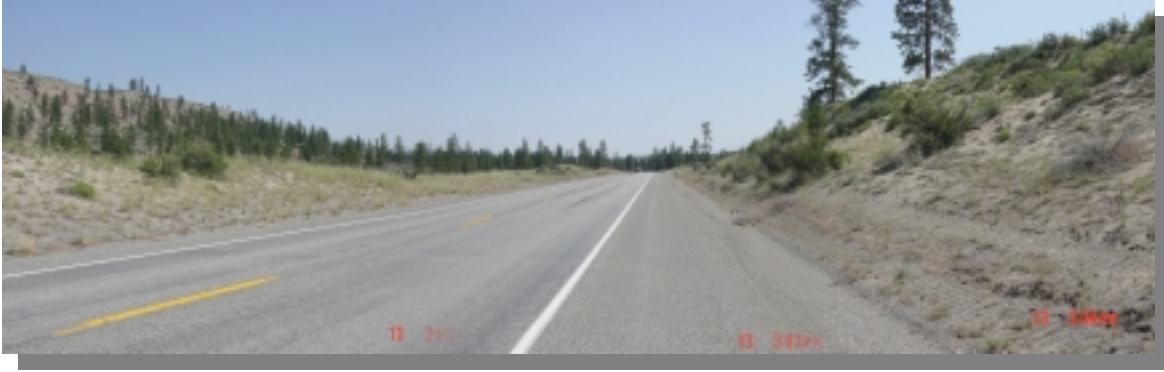
**Figure 25. Landscape Unit 3 northern boundary, view south.**

The view from the southbound lanes differs because the trees begin more abruptly from this direction of travel and the sense of enclosure is greater.

From this direction there is a slight dip in the ephemeral ratings because the grasses and seasonal flowers are less visible from this direction of travel – the pines dominate the view. Vegetation ratings average above 5 and have a peak of 6 through the first two-thirds of the landscape unit.

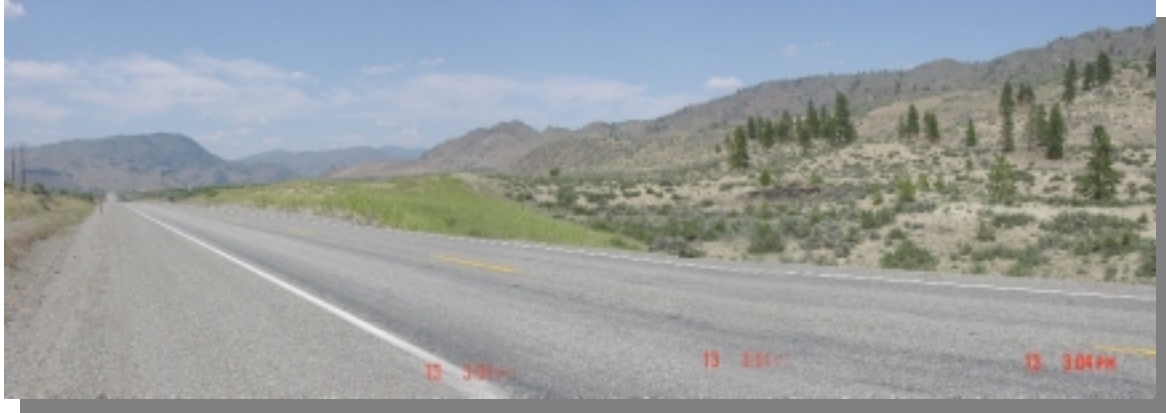
Figure 28. Topography of Landscape Unit 4. View Northbound

Landscape Unit 4 runs from MP 274.3 to MP 278.7. The feeling of enclosure opens to a broad valley and the feeling of prospect returns. The highway is slightly elevated with hills rising a few hundred feet to the east. Figure 28 shows the view northbound with sand dunes covered in dune grass on the east slope. The view of the mountains and high benches to the north and west is dramatic.

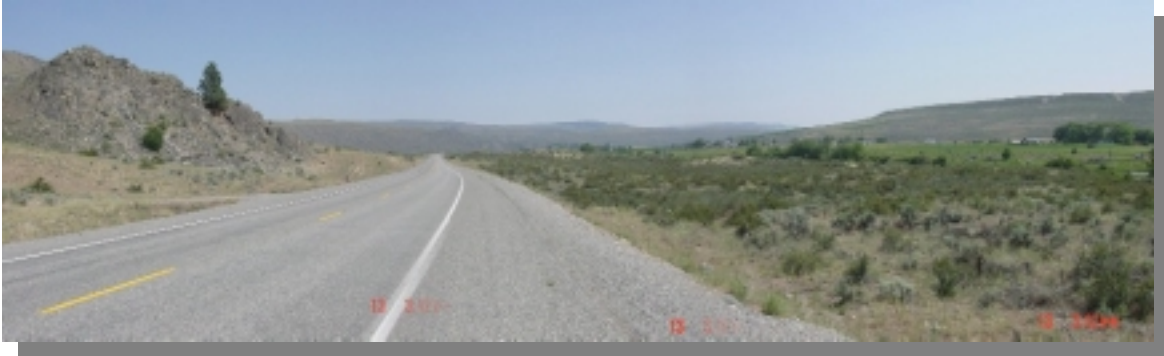
**Figure 31. Landscape Unit 4, view southbound**

Landscape Unit 4 Southbound runs from MP 278.65 to MP 274.28. In this landscape unit, as you drive southbound, the mountains rise on the left. The Okanogan River is in the distance to the west and can only be viewed briefly in the northern end of the landscape unit. High terraces are seen on the hills to the west, beyond the river. Figure 31 shows the topography of this landscape unit.

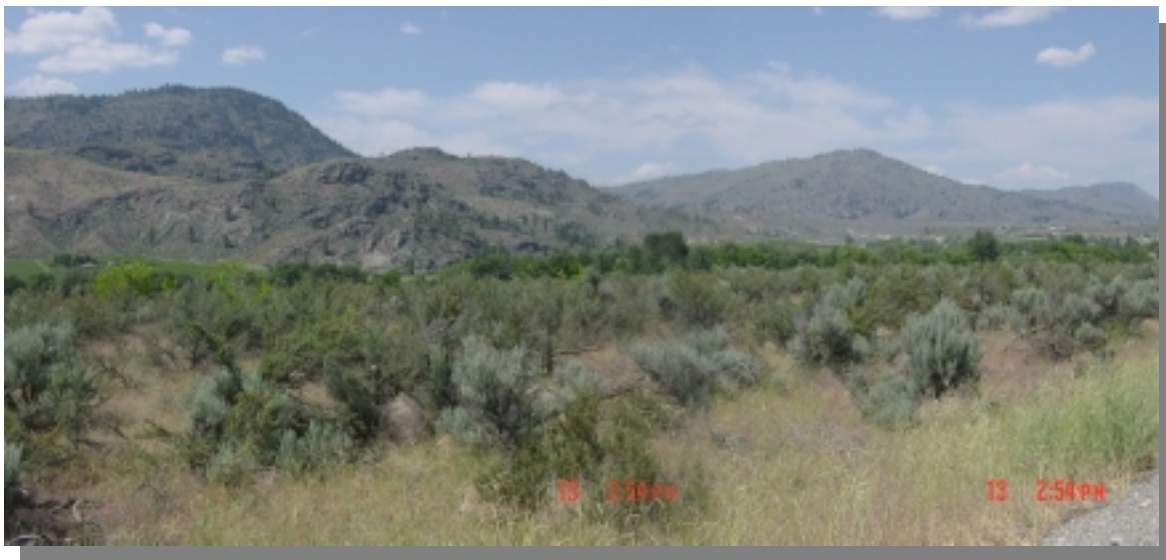
**Figure 34. View north from MP 286.44 toward Malott**

Traveling north, human impacts become more visible and frequent. Views of the industrial areas around Okanogan and Omak and the strip-mall and fast-food development at the junction of SR 97 and SR 215 lower the human, unity, and intactness ratings for over one-third of this landscape unit.

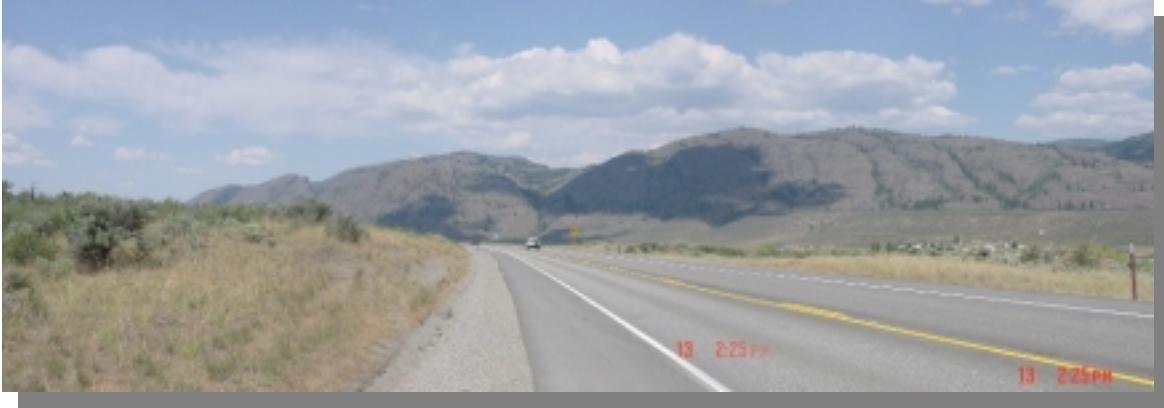
**Figure 41. Landscape Unit 6 view northbound from MP 294.6**

Landscape Unit 6 runs from MP 293.2 to MP 294.7. This landscape unit is characterized by an open valley just north of Omak, seen in Figure 41.

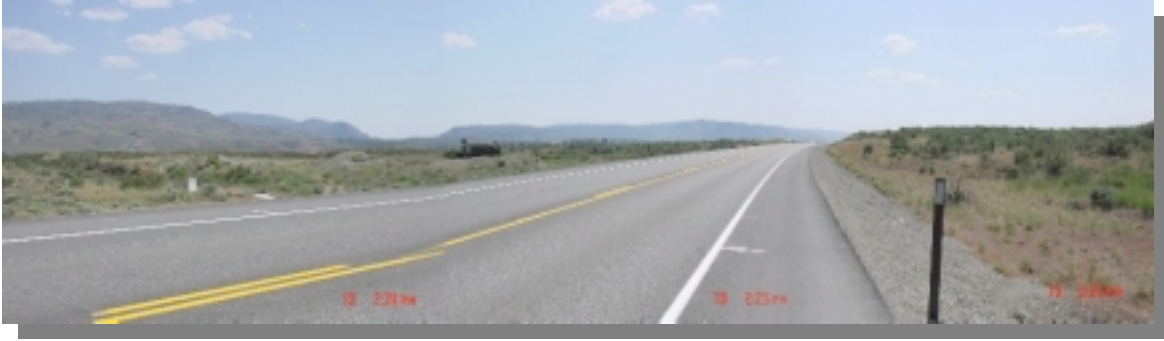
**Figure 44. View southbound from MP 294.66 Landscape Unit 6.**

There are wide sweeping vistas in Landscape Unit 6 southbound. As the traveler approaches Omak, industrial development and large signs on private land decrease scores for human, unity, and intactness. The view seen in Figure 44 is from MP 294.66, before development is seen.

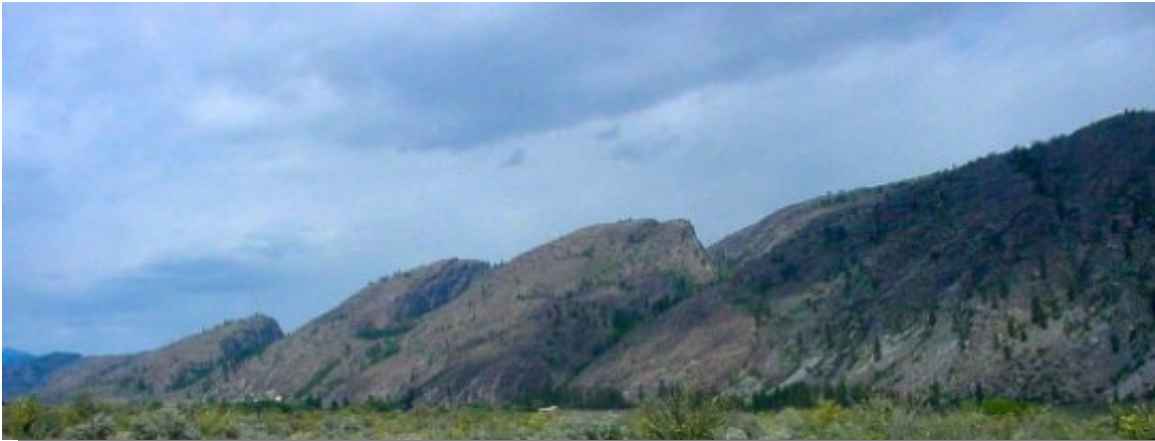
**Figure 47. Wave-like mountains near Riverside.**

Landscape Unit 7 begins when the wave-like rocks, to the east, above the town of Riverside are revealed when traveling northbound. This Landscape Unit runs from MP 294.7 to MP 300.5 where the form of the rock is no longer discernable from the northbound lanes. This unit has some of the most spectacular scenery in the corridor, as seen in Figure 47.

These mountains that lean, as they are described by a tribal elder, are unique and distinctive and rate the highest landform score of 7. Figure 48 shows the view of the entry to McLoughlin Canyon from MP300.12. This canyon is of historic significance and an additional view of this area is found in Appendix B.

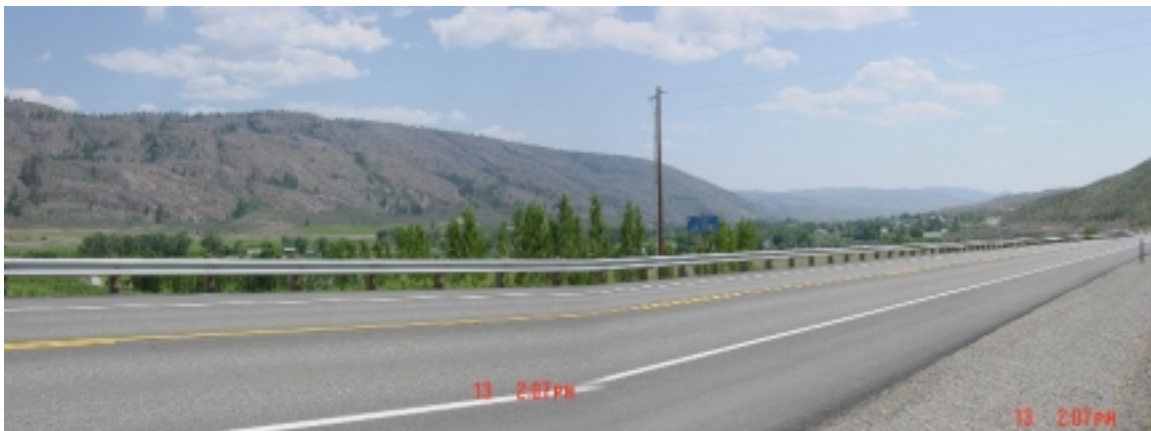
**Figure 51. Riverside and its mountain backdrop seen in Landscape Unit 7 Southbound.**

The southbound view in this area is less dramatic than the view from the northbound lanes. The mountains to the east, so dramatic when seen from the south, are seen as folds with vegetation lining the depressions. The town of Riverside is seen in the distance in Figure 51.

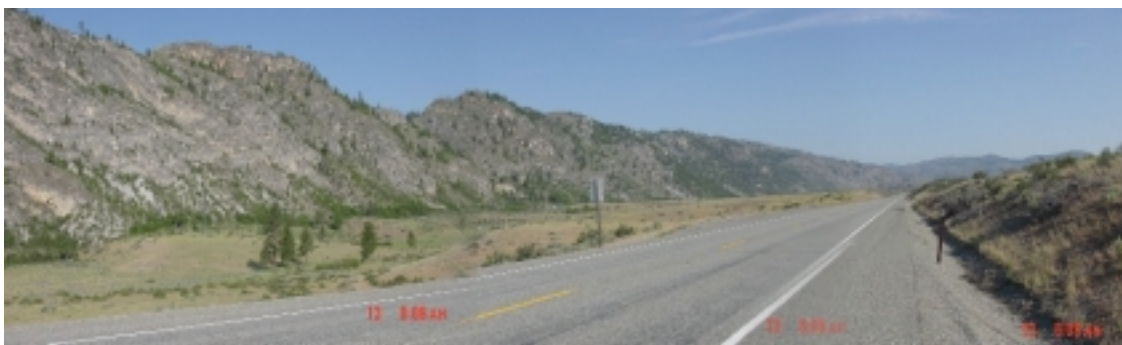
**Figure 54. MP 302 view North**

Landscape Unit 8 runs from MP 300.5 to MP 304.2. The landform is characterized by granite mountains that rise on the west. In this Landscape Unit, the river flows behind the mountains to the east and is not visible from the road. Because the mountain rises so steeply to the west, this landscape unit has dramatic mountain views.

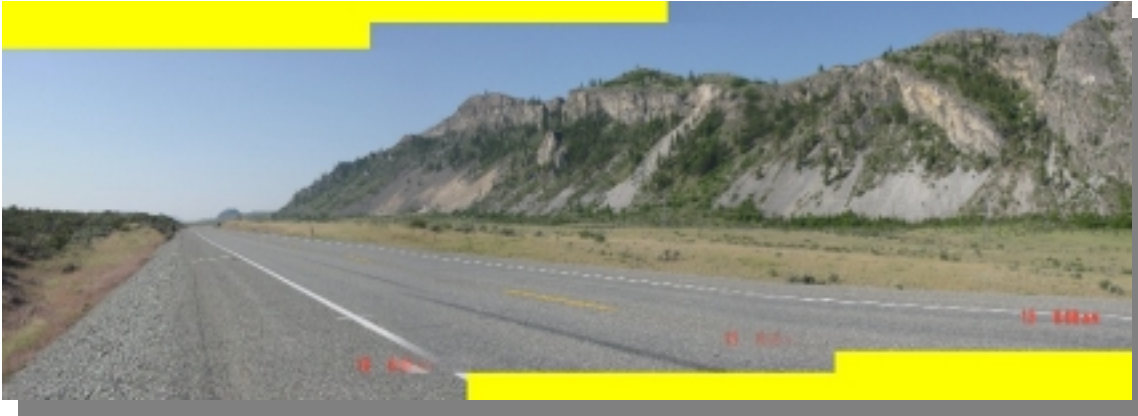
**Figure 57. Landform in Landscape Unit 8, view southbound.**

From the southbound lanes of travel, the mountains rise on the right. They are memorable and rate a score of 6. This view can be seen in Figure 57.

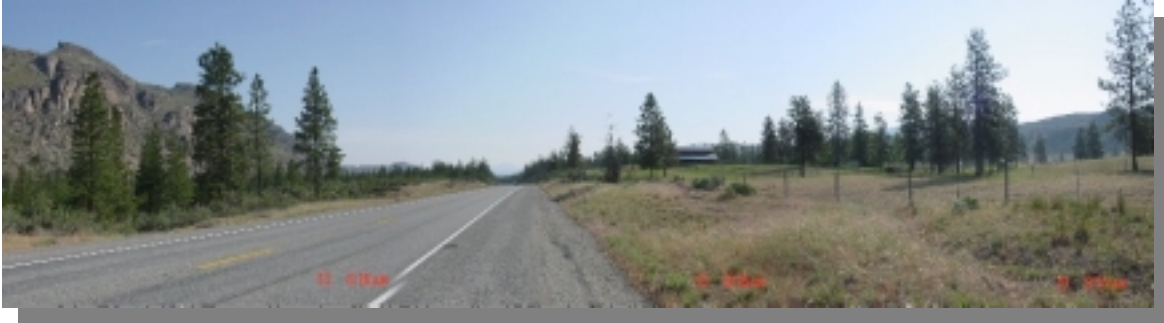
**Figure 60. Topography seen viewing northbound in Landscape unit 9.**

This landscape unit runs from MP 304.2 to MP 307.7 and has a forested character. This landscape unit is similar to Landscape Unit 3. There are old Ponderosa pines growing on ancient sand dunes and the trees provide a sense of enclosure in this area. However, beyond the pines the valley walls are close to the road, enforcing the sense of enclosure and refuge. There are homes to the east of the highway in this landscape unit.

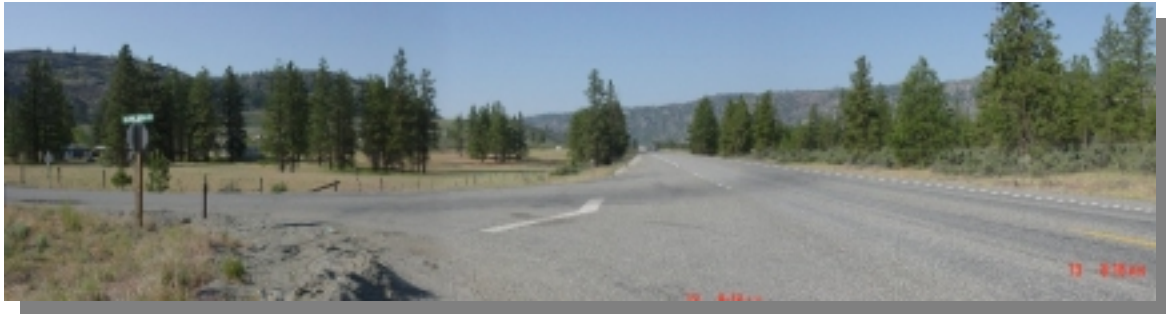
Figure 63. View from MP 307 view south

The view in Figure 63 is from MP 307 looking south. Power transmission lines and phone lines lower the scenic ratings along this corridor. There is a view of an ephemeral pond, which spikes the water rating.

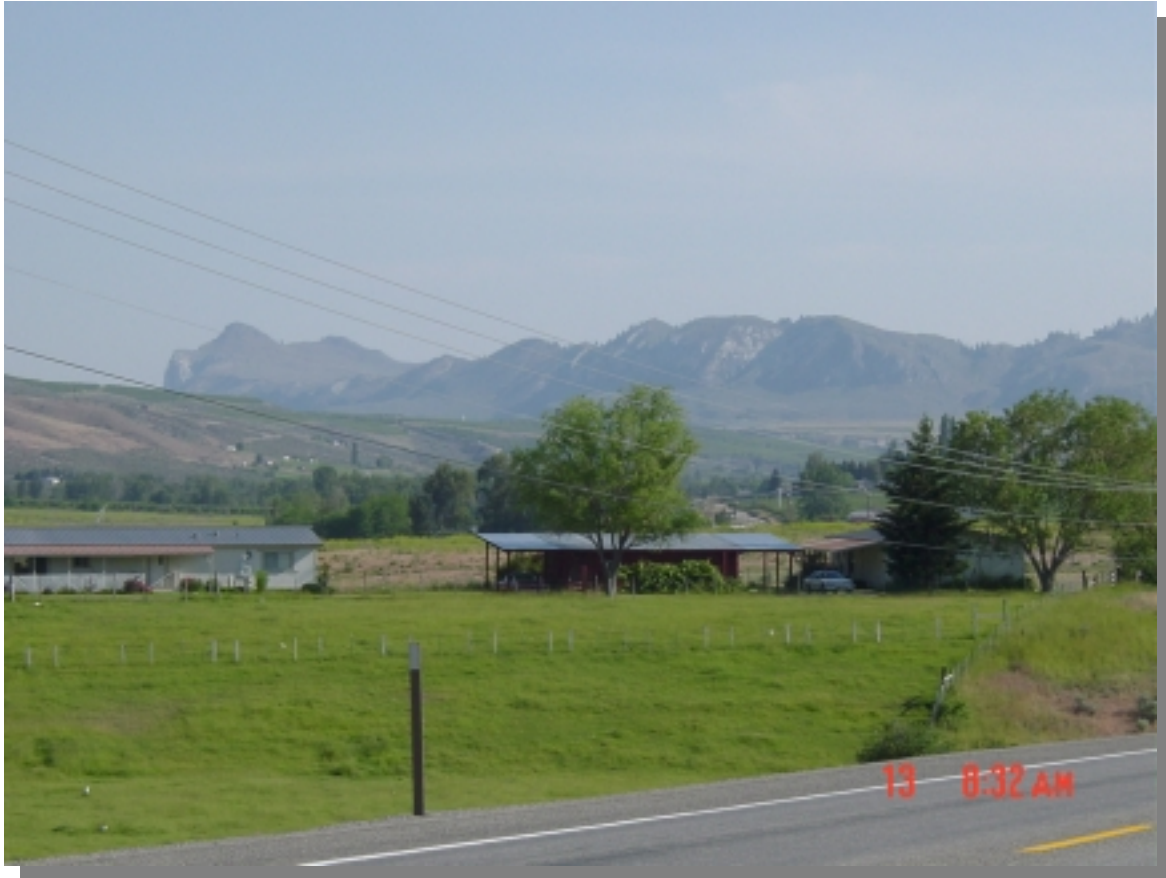
**Figure 66. White Stone Mountain in the background.**

Landscape Unit 10 runs from MP 307.7 to MP 315.8. In this section of the highway, the Ponderosas are no longer present beside the road. The view opens up again, but there is a gradual slope up to the west and mountains rise more dramatically on the east. This landscape unit has a rural character classification. There are occasional homes, a mill site, and an irrigation district settlement pond with accompanying pumps and pipes. In Landscape Unit 10, there are good views of White Stone Mountain to the northwest, seen in Figure 66.

The power and phone lines disrupt the view, but otherwise this rural landscape is scenic. Figure 67 shows typical topography in this landscape unit.
